Accelerator Department
BROOKHAVEN NATIONAL LABORATORY
Associated Universities, Inc.
Upton, New York

AGS DIVISION TECHNICAL NOTE

No. 85

TESTS OF BRACKET AND COIL INSULATION - MAGNETS A-1,
B-1, G-10, AND G-11 AFTER APRIL 1971 SHUTDOWN

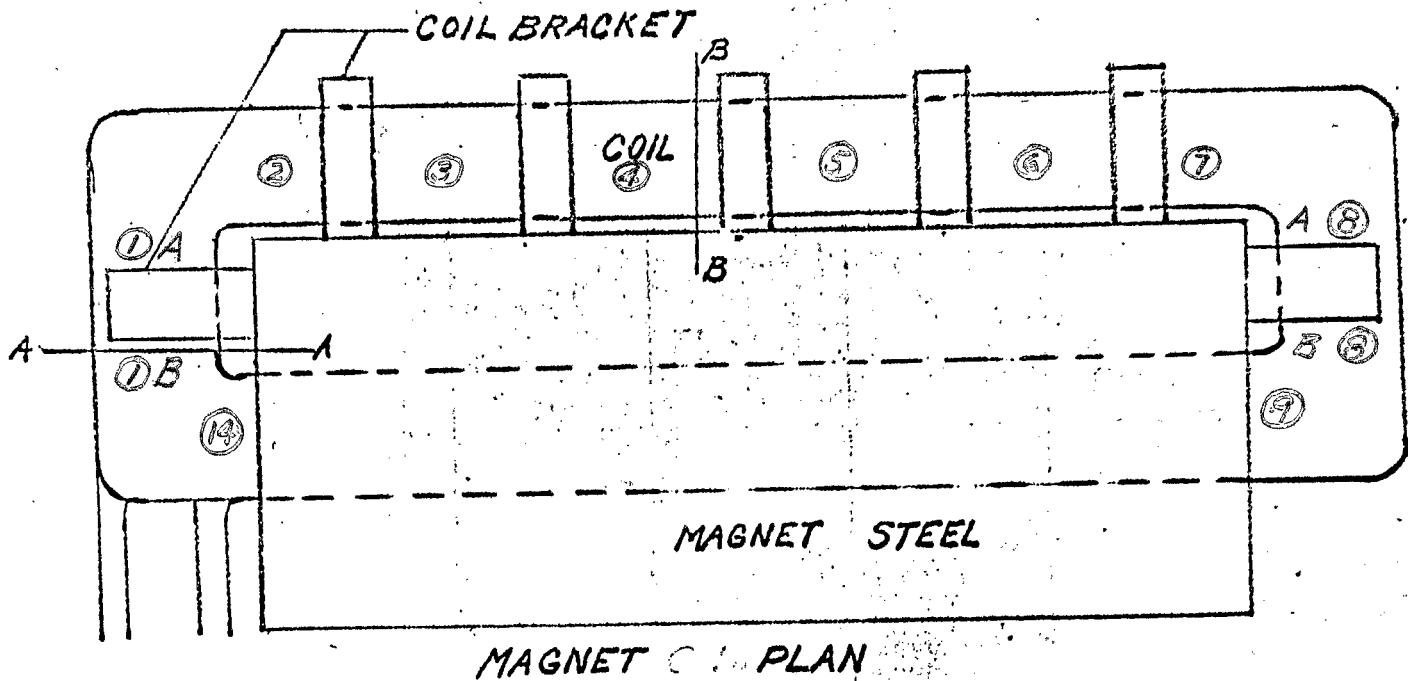
FIG-1

TEST LOCATION ①; ①- WHEN COILS ARE ASSEMBLED - TOP SURFACE
 OF TOP COIL AND TOP SURFACE OF TOP LOWER COIL

- 2) This insulation shall be installed at the upstream bracket and the first two brackets along the side of the magnet.
- 3) These sheets shall be cut larger than the present micarta so as to provide, if possible 3/4 in. additional creepage, on all sides, to the metal pad.

- 4) When making up the sandwich, the separate sheets shall be wiped clean and inspected for holes or foreign particles.
- 5) After the coils have been assembled on the magnet, surface and volume insulation resistance tests shall be measured following the procedure on Fig. 2 and Sheet No. 1 in the Appendix. The tests shall be made at locations 1A and B, 2, 5, 8A and B Fig. 1. This will serve as a bench mark for later after service tests.

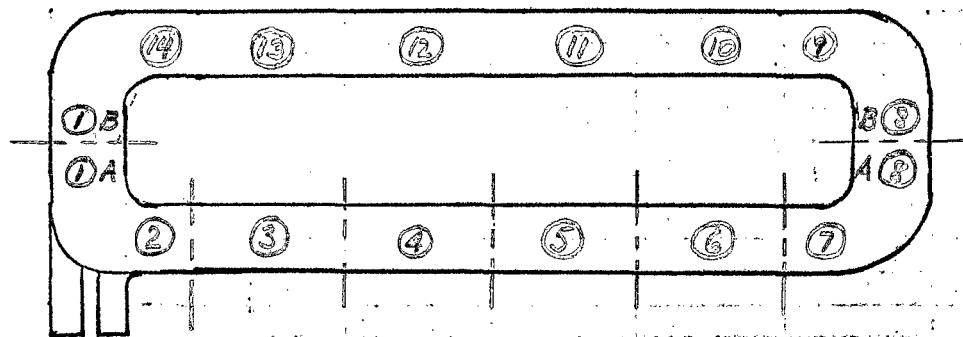
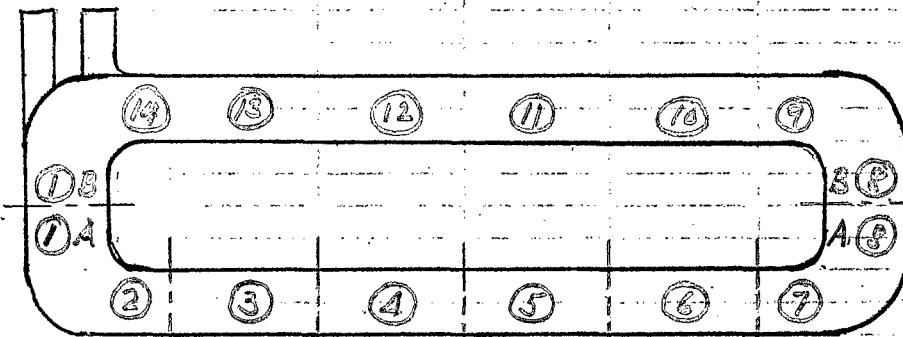
PROCEDURE: FIG2

INSULATION TEST - MAIN MAGNET COILSLOCATION OF TEST ELECTRODES - ①WHEN COILS ARE NOT ASSEMBLED ON MAGNET
LIST COIL NO., - POSITION, - SURFACE (TOP OR BOTTOM)

PROCEDURE - SURFACE INSULATION RESISTANCEVOLUME INSULATION RESISTANCE - 1 3/4"TEST - MEGGER - 1000, 2500, 5000 VOLTS
