AGS Division Technical Note
No. 184

IMPROVED MECHANICAL SEAL FOR ALUMINUM VACUUM WINDOWS

E. Rodger

December 13, 1982

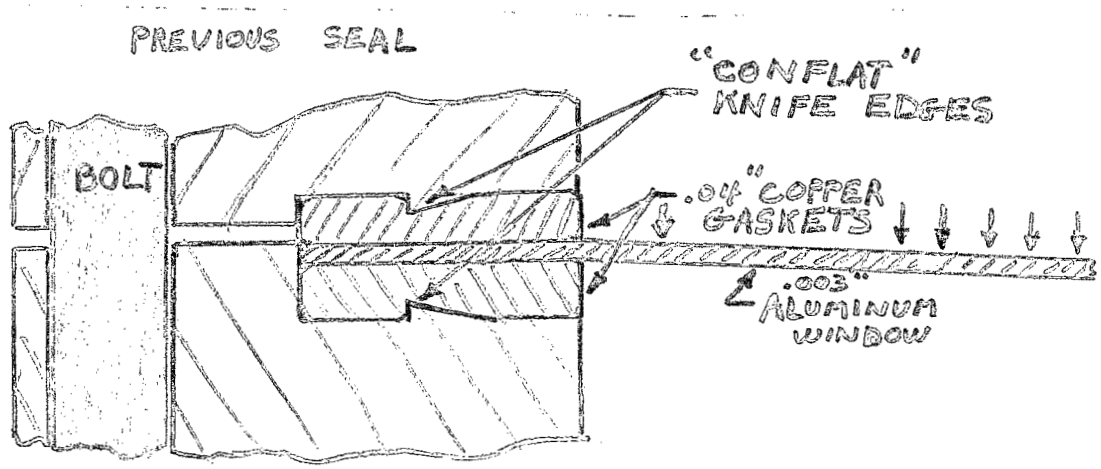
FIG. 1

This design proved troublesome for two reasons. First, the copper-to-aluminum seal was marginal because the high stress of the knife edge-to-copper contact was dissipated in traveling through the copper. This was evident by the fact that the minute surface scratches on the copper gasket were not completely obliterated by the window at the sealing area. Second, extensive copper-aluminum corrosion was observed across the seal area on a leaking unit. These observations lead to the design of a mechanical seal in which the stainless flange is clamped directly to the aluminum window as shown below.

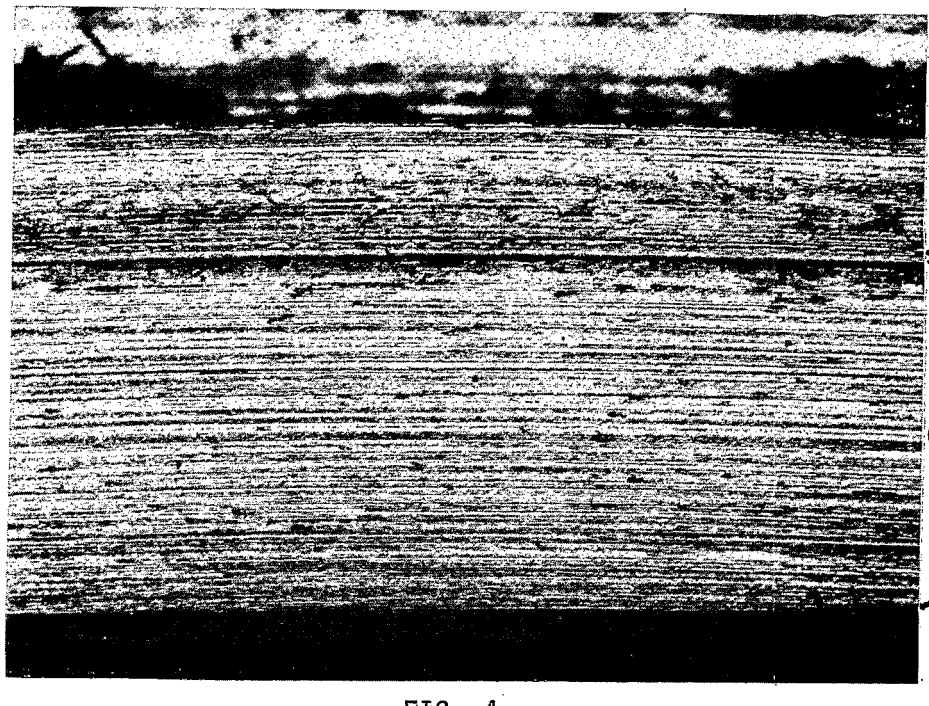
FIG. 4

TOP FLANGE
(MATES WITH FIG. 3) (38X)

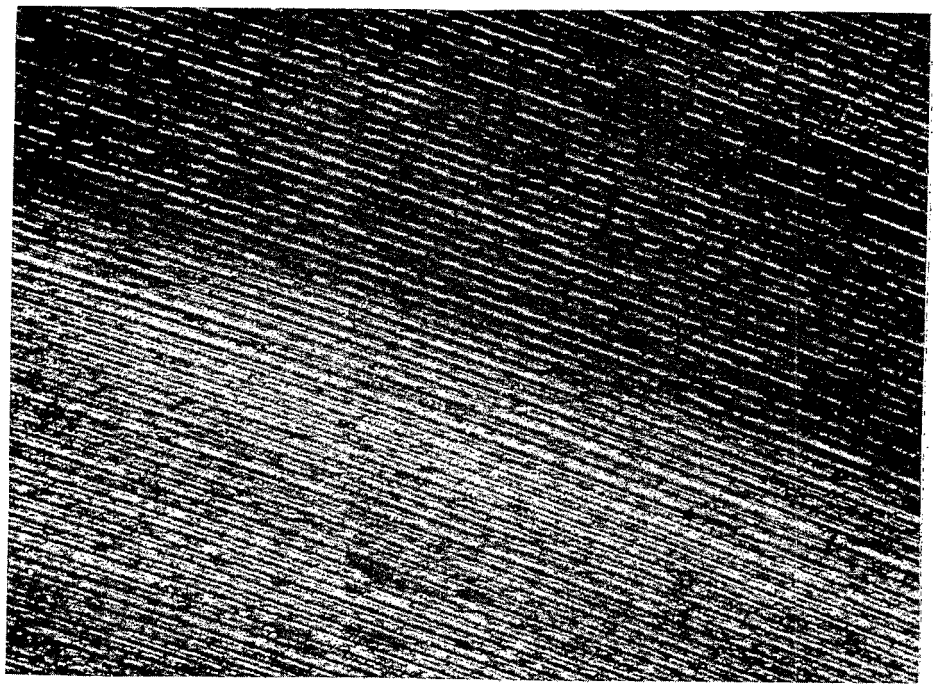
FIG. 6

BASE FLANGE
(MATES WITH FIG. 5) (38X)

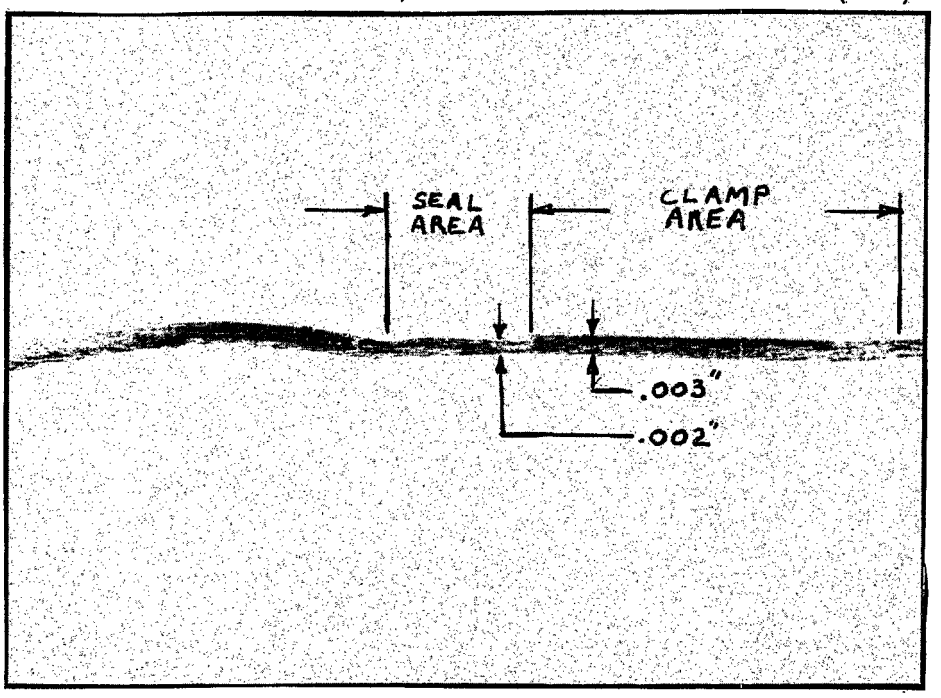
FIG. 7

CROSS SECTION OF WINDOW
SEAL/CLAMP AREAS (38X)
